DSTO-TR-0366

Evaluation of Innovative NDI
Methods for Detection of
Widespread Fatigue Damage

P. Khan Sharp,
D.E. Rowlands and G. Clark

**Airframes and Engines Division
Aeronautical and Maritime Research Laboratory**

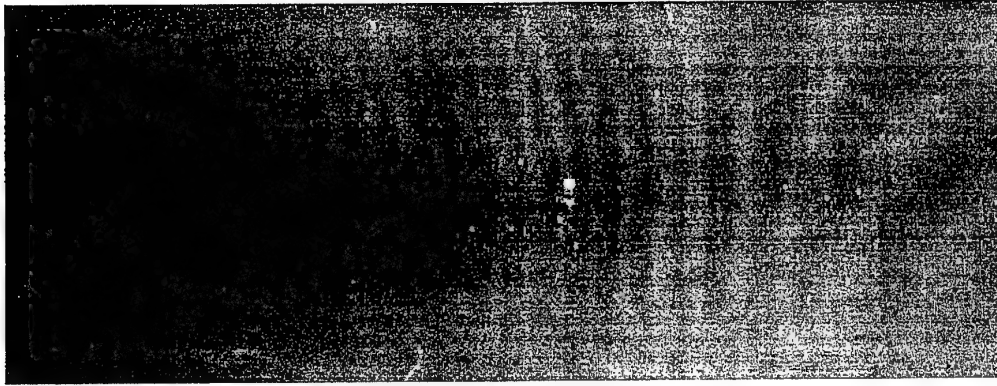
Figure 11: Holographic image from Plate No. 1b.

The initial plates were made by Bob Clark from ADFA; the fringe contrast appeared to be reasonably good, with plenty of fringes. For plate No. 1a, exposure time was 0.5 seconds at 50MPa and 250MPa. The first plate had large fringes in the plate from specimen reflections due to the curved polished nature of the surface. For plate No. 1b, exposure time was 0.3 seconds at 50MPa and 250MPa.
